# SMITHFIELD-LIBERTY HELIX RAMP REHABILITATION

## SMITHFIELD-LIBERTY HELIX RAMP REHABILITATION

### LONGEVITY FEATURES

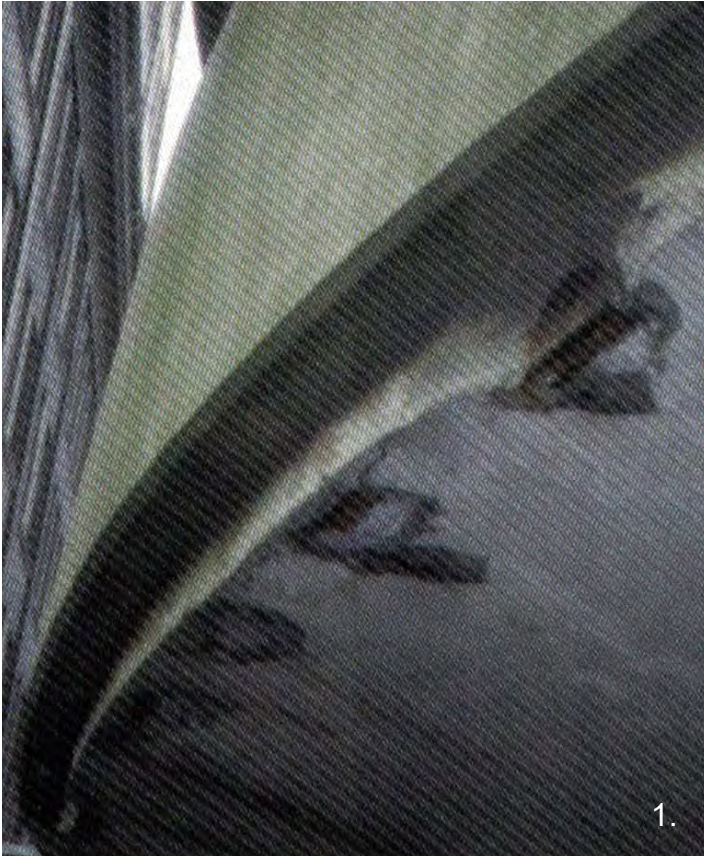
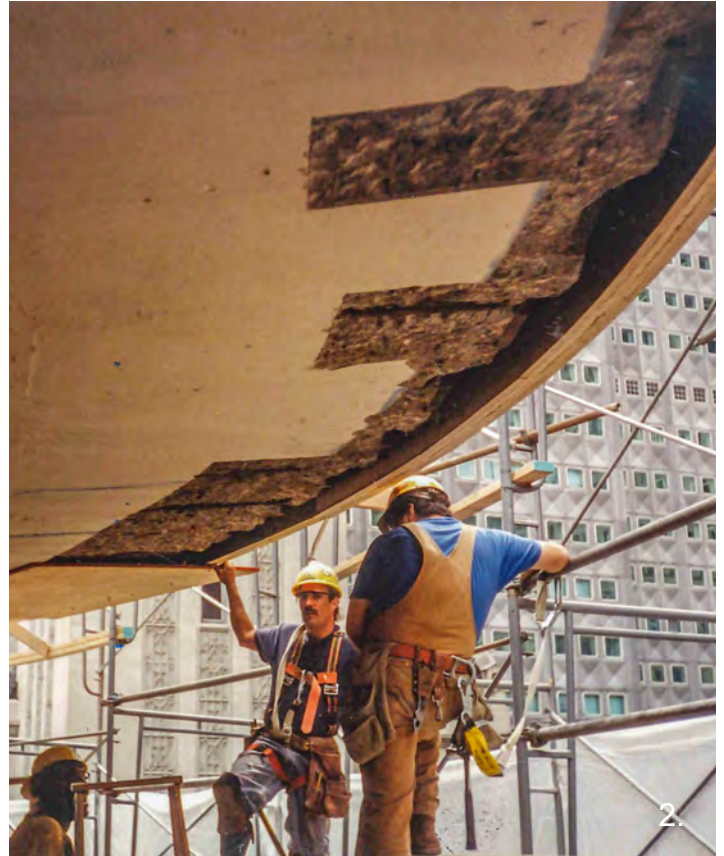
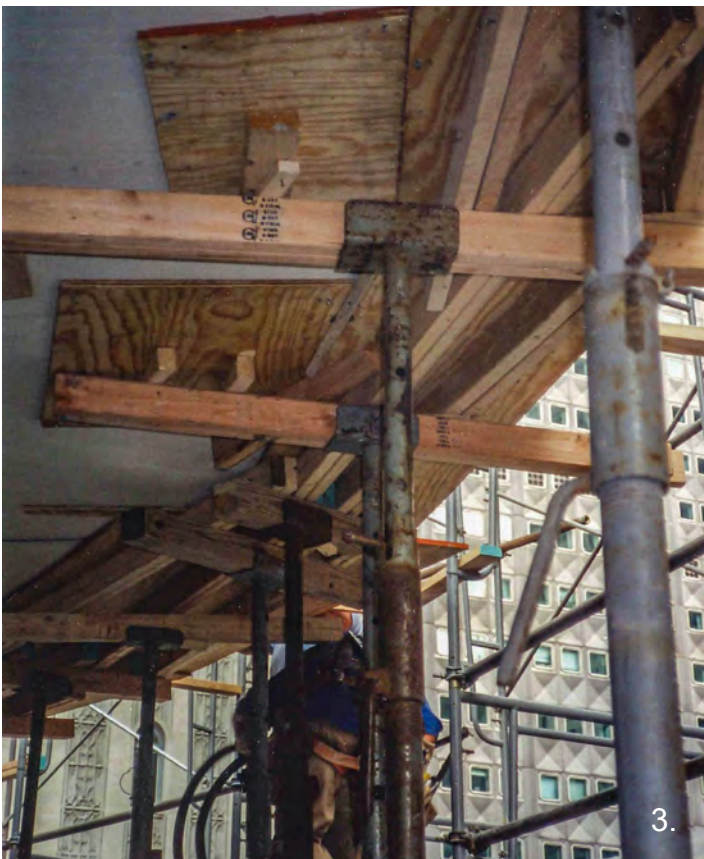
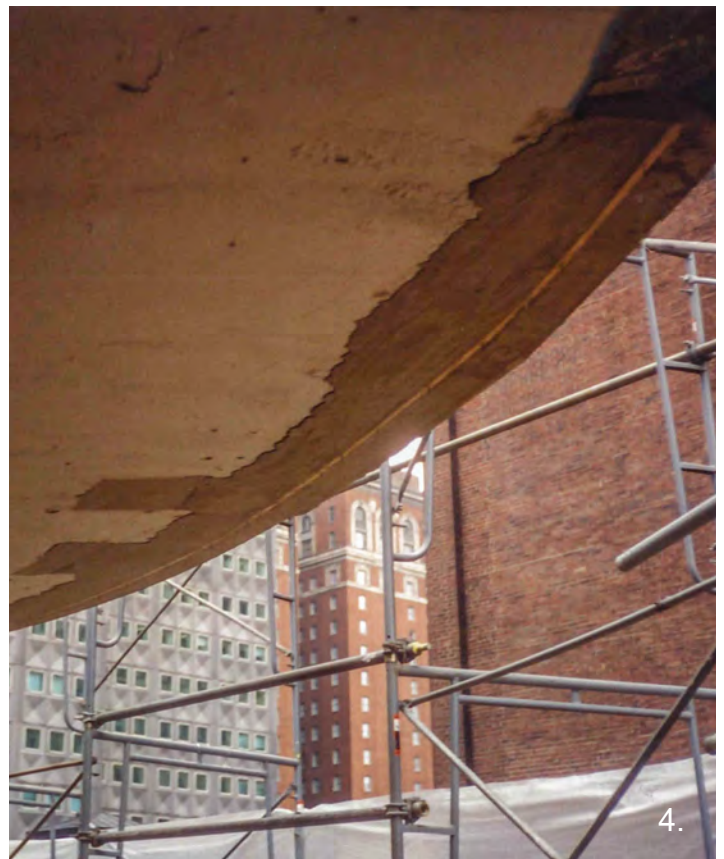
Pictures below, from left to right are as follows - 1) Original slab edge deterioration; 2) Slab edge soffit demolition and formwork; 3) Slab edge formwork and shoring; 4) Completed slab soffit repair with integral drip edge

To address the concrete cover problem on the post-tensioned reinforcing anchor plates on the perimeter of the ramp, a new concrete cap was recommended to provide suitable cover for the plates. In addition, a drip edge was recommended to prevent water from running down the underside of the ramps. Although this repair detail reduced the depth of the reveal at the slab perimeter, the architectural appearance of the ramp was not significantly changed. To address the concrete cover problem on the existing reinforcing steel in the knee walls, it was recommended that patch repairs be slightly over-built to obtain suitable concrete cover on the reinforcing steel. The visual effect of the patch overbuild was reduced by enlarging the patch area to the extent where existing reinforcing steel had sufficient concrete cover.

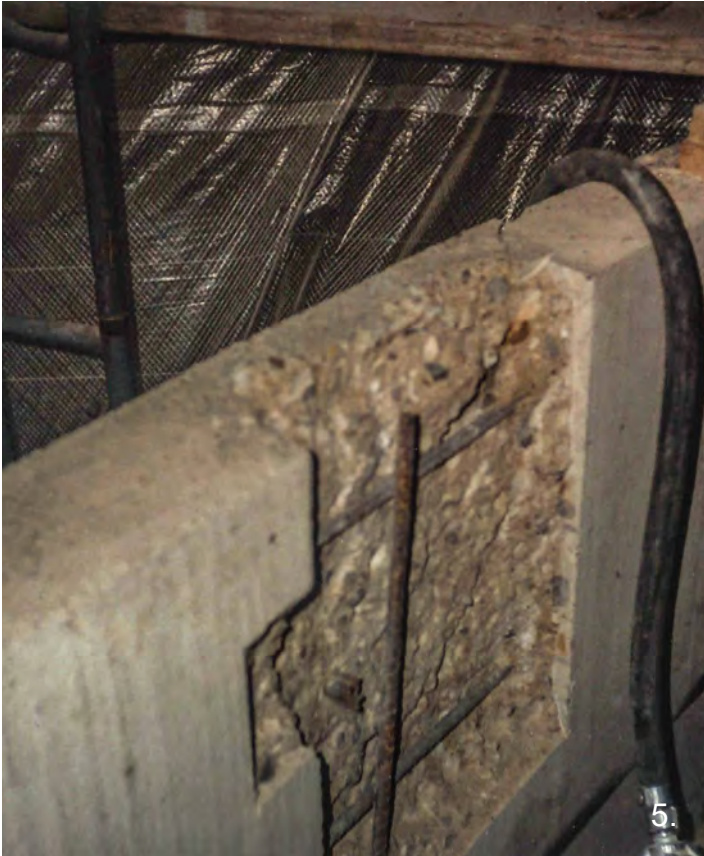
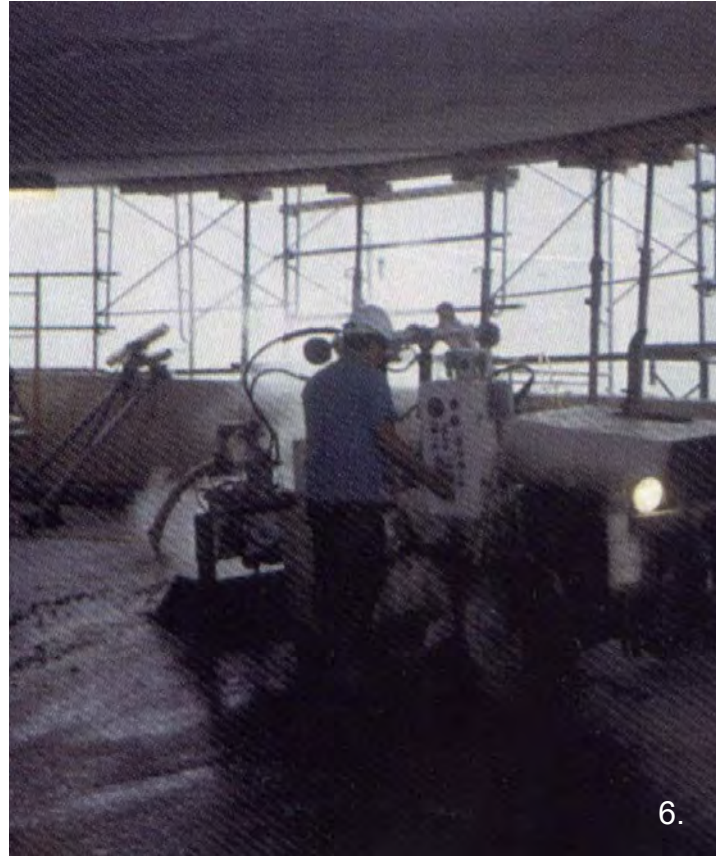
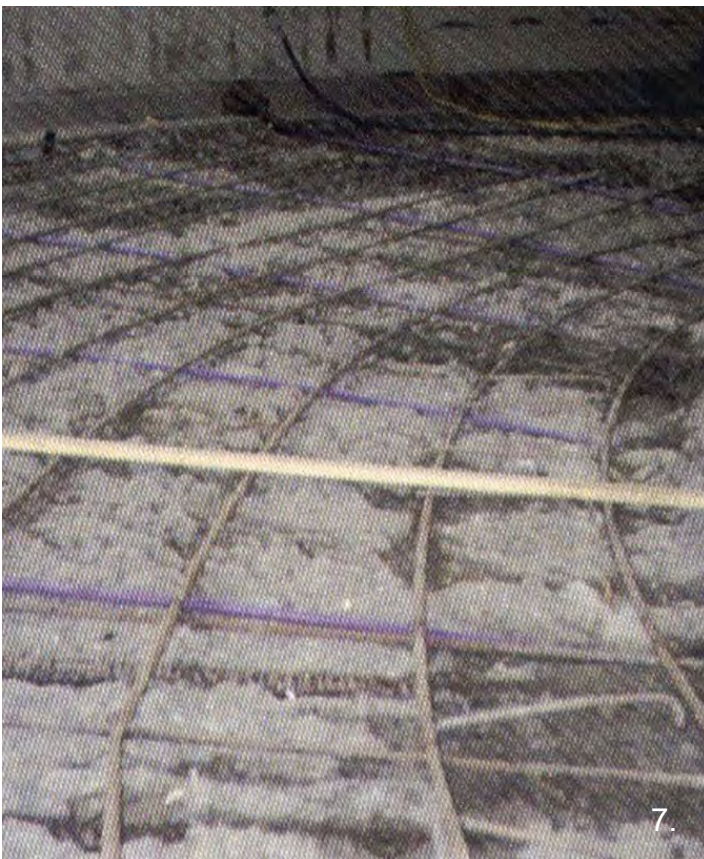
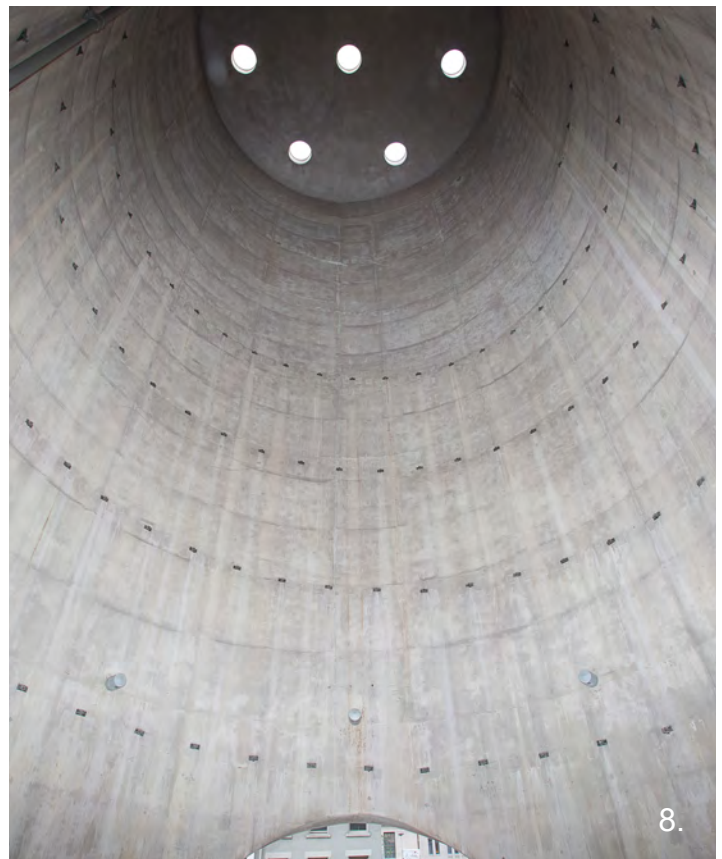
*Pictures below, from left to right are as follows - 5) Knee wall vertical repair demolition; 6) Hydrodemolition of ramp slab upper concrete layer; 7) Demolished ramp slab surface with supplemental post-tension reinforcing installed throughout central cylinder; 8) Exposed post-tensioned tendon anchor heads at central cylinder*

Once parking traffic was re-routed, the helix ramp was closed, and construction commenced. Given the aggressive construction schedule and limited work area, methods to expedite the repair process had to be implemented. The primary time saving measure utilized during the rehabilitation was hydro demolition, which is a process utilizing water under very high pressure (about 10,000psi) to demolish concrete. This method was used in lieu of conventional jackhammers to remove the top section of chloride-contaminated concrete on the ramp slabs and resulted in significant time savings.
